**INTEGRATED WATER RESOURCES MANAGEMENT  
TRIAL IMPLEMENTATION – TESTING**

**LOCAL SERVICE PROVIDERS  
WORK PACKAGE 3: WC/WDM MVOTI – UMZIMKULU  
UGU DISTRICT MUNICIPALITY  
STAGE 1 REPORT  
FINAL**

# UGU DISTRICT MUNICIPALITY STAGE 1 REPORT

## STAGE 1 REPORT

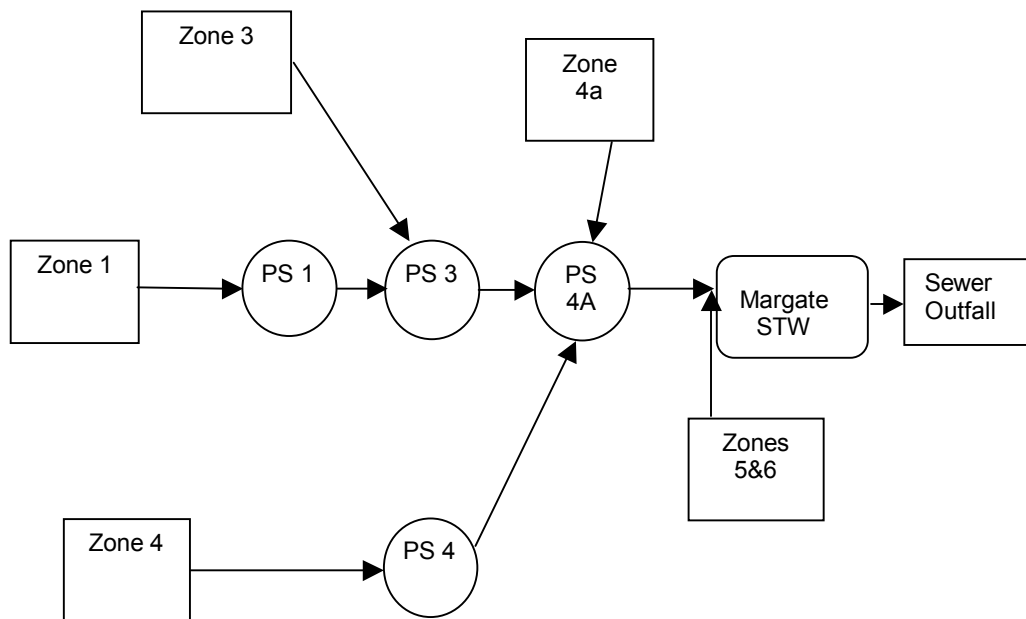
**Figure 4.2: Sewer Flow Diagram**

The pilot project area is located in the centre of Margate on the South Coast of KwaZulu Natal. The area is divided into several catchment areas as shown in Annexure 1. Pump Station 1 pumps into Pump Station 3. Pump Station 3 bypasses Pump Station 4 and pumps directly into Pump Station 4A situated at the Margate Sewer Treatment Works. The catchment draining to Pump Station 4 is also pumped directly to Pump Station 4A. Pump Station 4A also receives sewage from gravity pipelines. Pump Station 4A pumps the sewage to the head of the works. A gravity sewer also enters the head of the works. After treatment at the Works the final effluent is piped into the sea.

This is shown diagrammatically as follows:

The marginal operating costs within the network, which are basically the electrical power costs at the pumping stations have been estimated as given Table 7.2 above. As shown in Fig. 4.2, sewage from Zone 1 is pumped at PS 1, 3 and 4a, i.e. a total of three times. Similarly sewage from Zone 2 is pumped twice, and sewage from Zone 4 is pumped twice. The flows from catchments 5 & 6 are not pumped at all (except for within the STW in the form of return activated sludge that is set typically at 1 x the dry weather flow. The vital point to appreciate is that a kilolitre of infiltration or inflow that is prevented from entering the network in catchment 1 saves 30 cents of electrical power cost, whereas a kilolitre in catchments 5 & 6 saves only 1 cent. Thus apart from environmental and public health considerations, the highest priority should go to reducing inflow and infiltration in catchment 1, followed by catchment 3, 4 and 4a in that order. Of course each measure must be considered on its own merits.

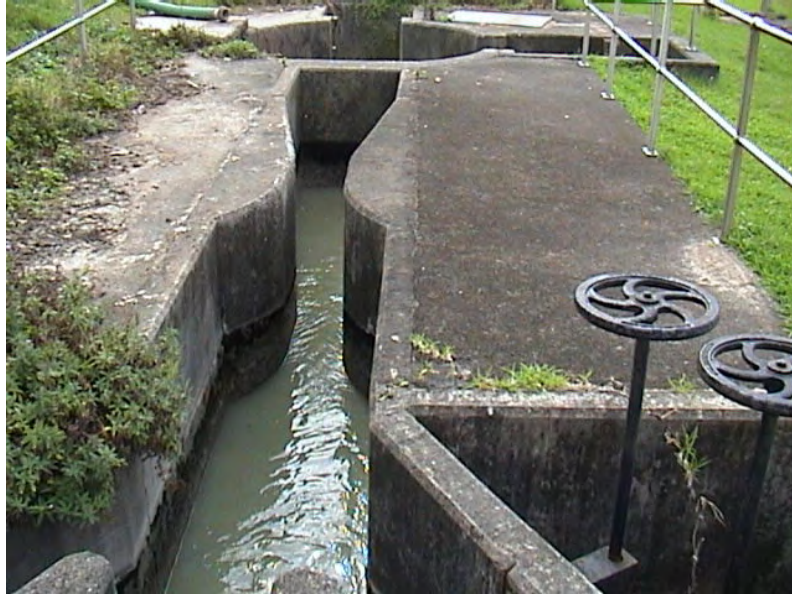
There exists a flume at the end of the works before the sewer leaves the sewage treatment works. The flow is measured at the flume, and these are included in Annexure 7.

*Photo 1: Measurement Flume at STW (outfall)*

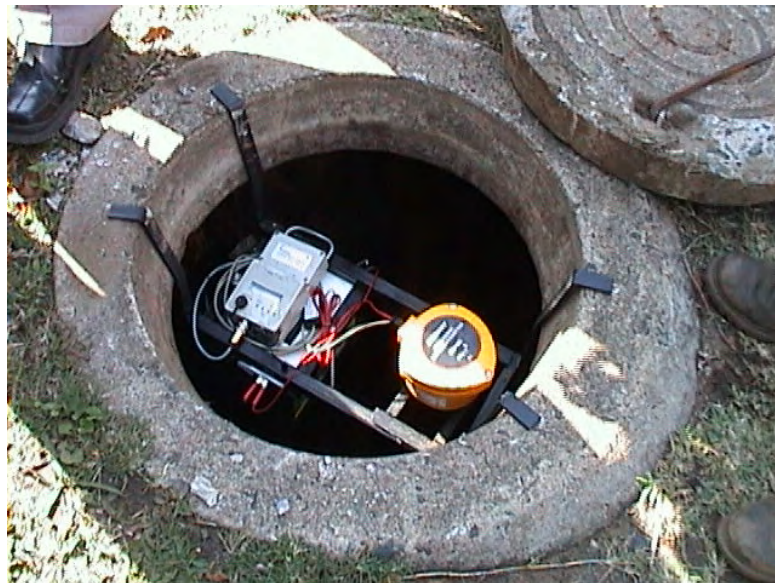
The catchment areas were divided into dry and wet sub-catchment areas. The catchment areas consisted of areas of high water table, and these were identified by visual inspections. The flows in each of the sewers were then measured using the ultrasonic flow measurement instruments.

*Photo 2: Ultrasonic Flow Measurement and Data Logging at Manhole*

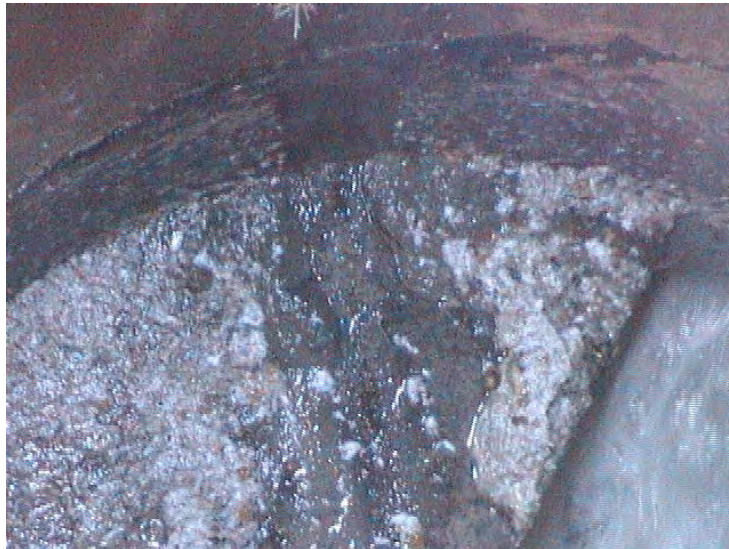
In all areas where the groundwater level was found to be high, clear water was found to seep through the precast manhole rings. Approximately 75% of the manholes adjacent to Valley Street were found to have groundwater seeping through the manhole ring joints. Clear water was also found to seep into the manholes through the benching.

*Photo 3: Groundwater Infiltration in Manholes through Benching*

Based on the field survey carried out during the study, approximately 250 out of a total of 748 manholes or 34% have water seeping into the sewer through the joints between the precast manhole rings.

8. The manholes listed in Annexure 10 that were found to have joint leaks must be repaired to minimise the effect of infiltration at the manholes. The cost of repairing the joint leaks in 317 manholes is included as Annexure 11.

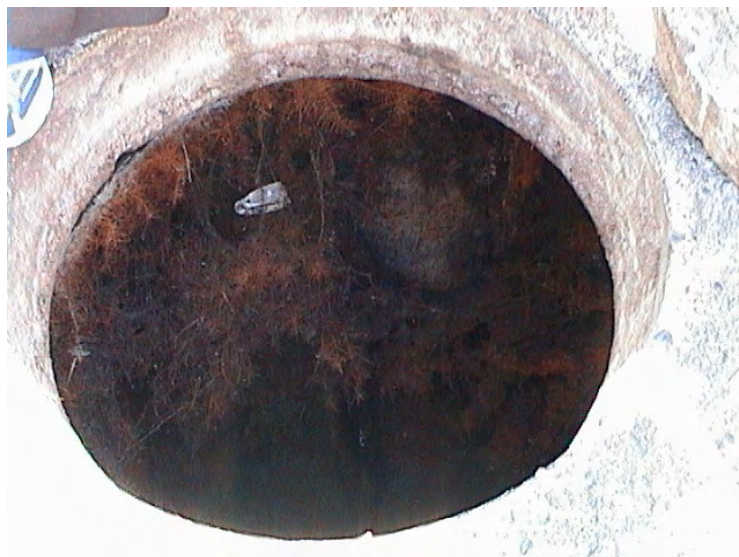
Some manholes are in the vicinity of wild fig or rubber trees and have been infiltrated by their root system.

*Photo 4: Penetration of roots into Manholes*

Field surveys have shown that approximately 35 manholes or 9% have roots penetrating the manhole joints.

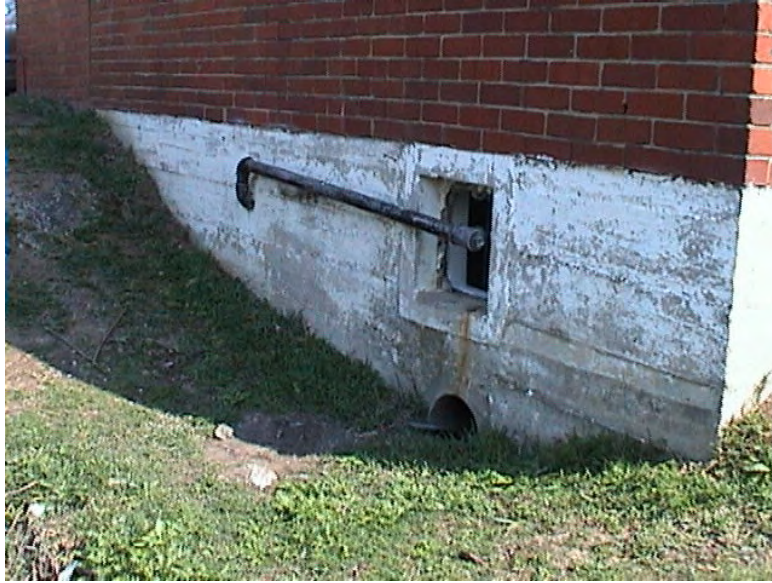
On 26 June 2003, the pumps at PS3 failed to turn on. The standby pump was also not in operation. The diesel pump ran through the night, until it ran out of fuel. Unfortunately, this occurred during heavy rainfall, and the sewage overflowed through the steel vent into the estuary. The following two photographs show the overflow weir and the estuary the raw sewage flows into in the event of pump failure. The pumps at Pump Station 3 fails on average five times a year.

*Photo 5: Overflow weir at PS3 into estuary*

6. At Section 9A to C97, any possible interconnections or possible leaks on both S/W and sewer systems needs to be investigated further.
7. The overflow vent at PS3 allows for the high flood waters from the estuary to flow into the sump. A non-return valve at the pump station, allowing the sump to drain freely into the estuary in the event of pump failure will help alleviate the problem.

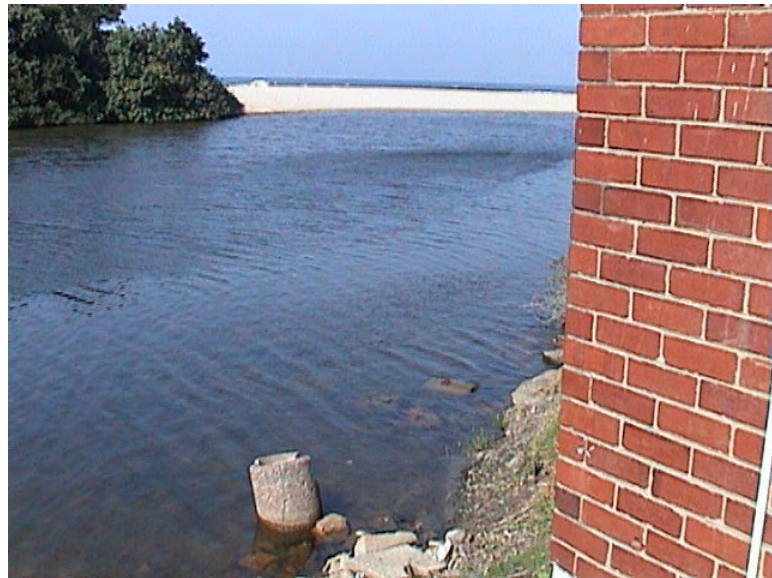
*Photo 6: Another view showing recreation estuary adjacent to PS3*

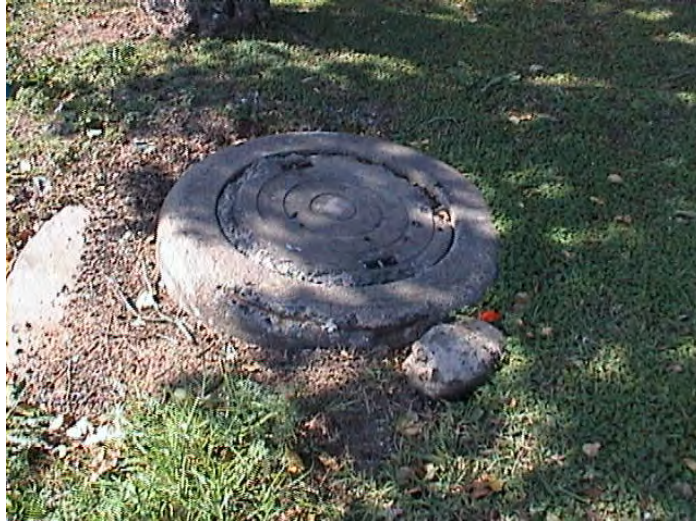
PS 4 has also failed on a number of occasions. Failure of the pumps results in the raw sewage venting through a blow-manhole adjacent to pump station. The area adjacent to PS4 shows evidence of raw sewage flowing into the stream, and this poses serious environmental and health risks. This is shown in Photo 7 below.

*Photo 7: Blow Manhole at PS4*

Constant failure of the pumps at PS4 results in the discharge of raw sewage on the open fields before it flows into the stream. This can present serious health problems, particularly to the children who use the area for recreational purposes.
